Re: Dairy Farmers of America, Cabool, MO

**UNSATISFACTORY FINDINGS  
RESPONSE REQUIRED**

**Missouri Department of Natural Resources  
Southeast Regional Office/Water Protection Program  
Report of Inspection  
Dairy Farmers of America, Cabool, MO  
950 Metrecal Trace Street/Cabool/Texas County  
MO-0002828  
July 31, 2019**

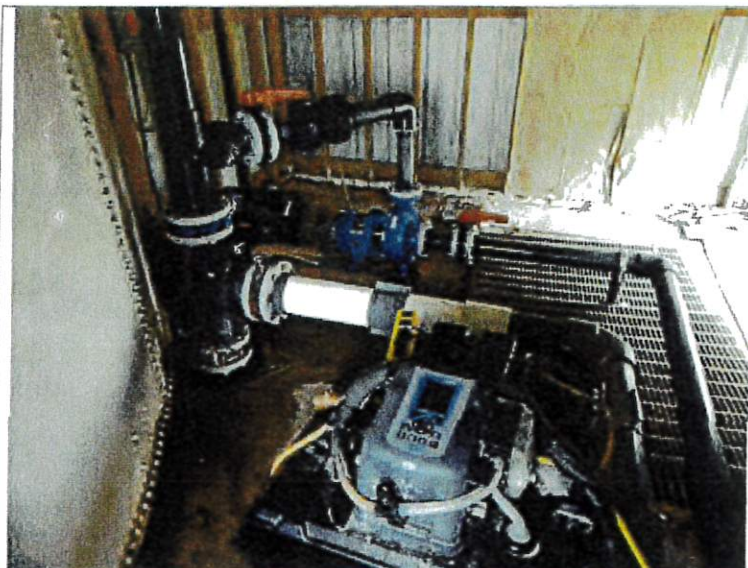
**Photo #:** 001  
**By:** John Chronister  
**Facility:** Dairy Farmers of America, Inc.  
**Permit:** MO-0002828  
**Location:** Texas County

**Description:** New plumbing @ equalization tanks

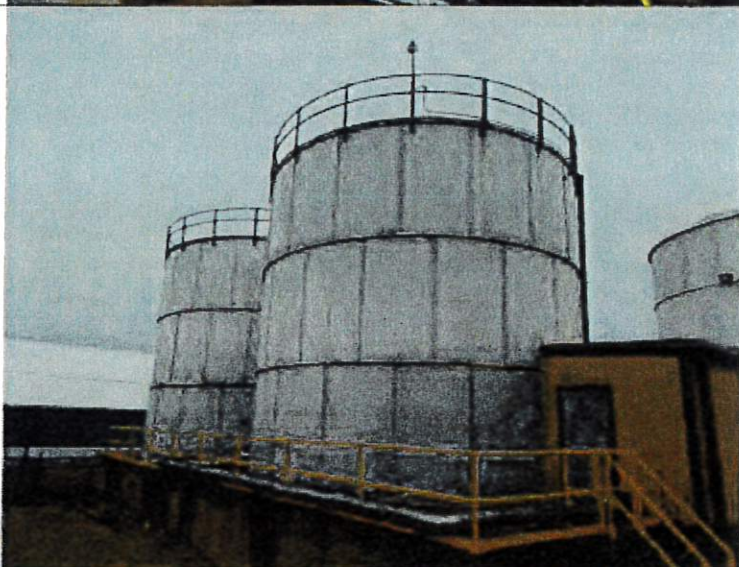
**Photo #:** 002  
**By:** John Chronister  
**Facility:** Dairy Farmers of America, Inc.  
**Permit:** MO-0002828  
**Location:** Texas County

We began at the head of the plant where the influent is pumped into (2) aerated 132,000-gallons equalization tanks. Aeration is provided by (2) Kaeser blowers. Two (2) 8" pumps move the effluent from the equalization tanks to the trickling filter. The trickling filter is also equipped with (1) recirculation pump to keep the media wet when there is no or low flow through the plant. This area has recently been upgraded with new pumps and plumbing. According to Mr. Henley, the traveling arm on the trickling filter is greased weekly and the orifices are cleaned 1-2 times monthly.

**Description:** Equalization tanks

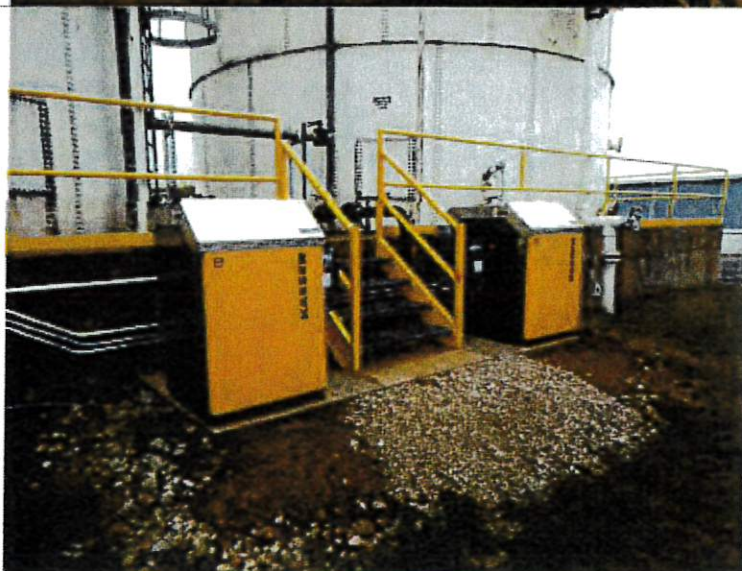
**Photo #:** 003  
**By:** John Chronister  
**Facility:** Dairy Farmers of America, Inc.  
**Permit:** MO-0002828  
**Location:** Texas County

**Description:** Blowers @ equalization tanks

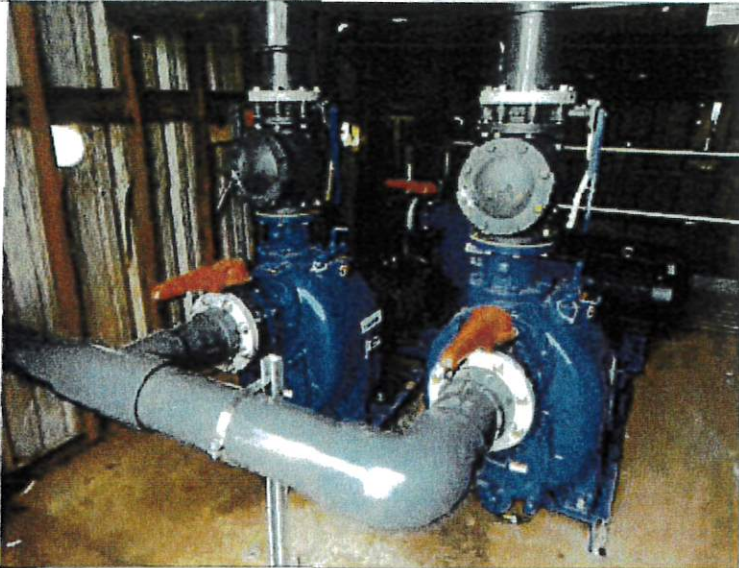
**Photo #:** 004  
**By:** John Chronister  
**Facility:** Dairy Farmers of America, Inc.  
**Permit:** MO-0002828  
**Location:** Texas County

**Description:** New pumps @ trickling filter

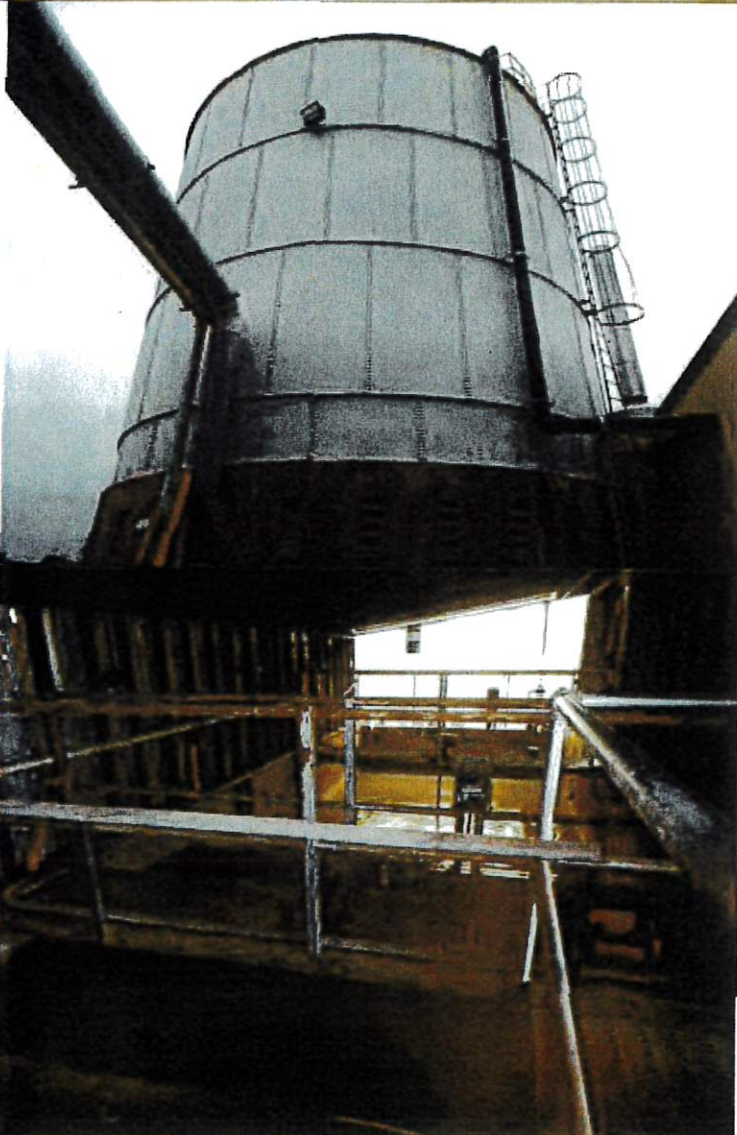
**Photo #:** 005  
**By:** John Chronister  
**Facility:** Dairy Farmers of America, Inc.  
**Permit:** MO-0002828  
**Location:** Texas County

**Description:** Trickling filter

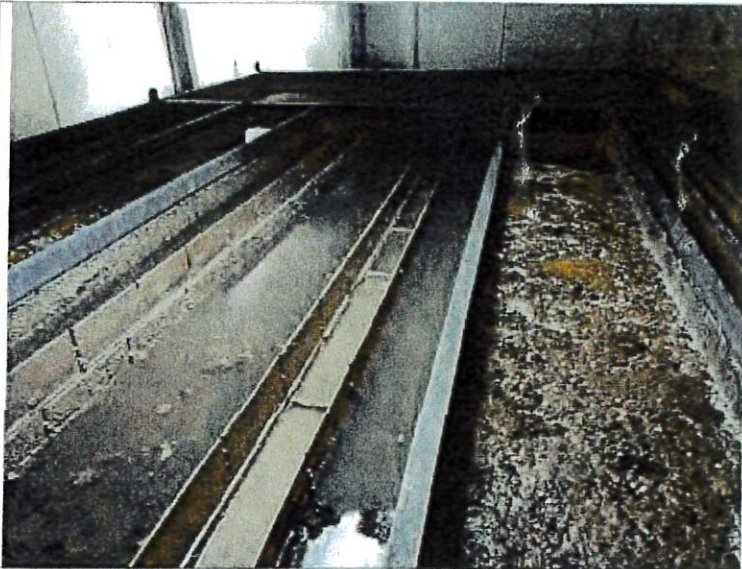
**Photo #:** 007  
**By:** John Chronister  
**Facility:** Dairy Farmers of America, Inc.  
**Permit:** MO-0002828  
**Location:** Texas County

After passing through the trickling filter, wastewater flows through the floc ditch and is pumped to the intermediate clarifier by (2) 4" pumps. According to Mr. Riley and Mr. Henley, upgrades are planned for this part of the plant. The wastewater then passes through the intermediate clarifier and flows to the oxidation ditch.

**Description:** Intermediate clarifier

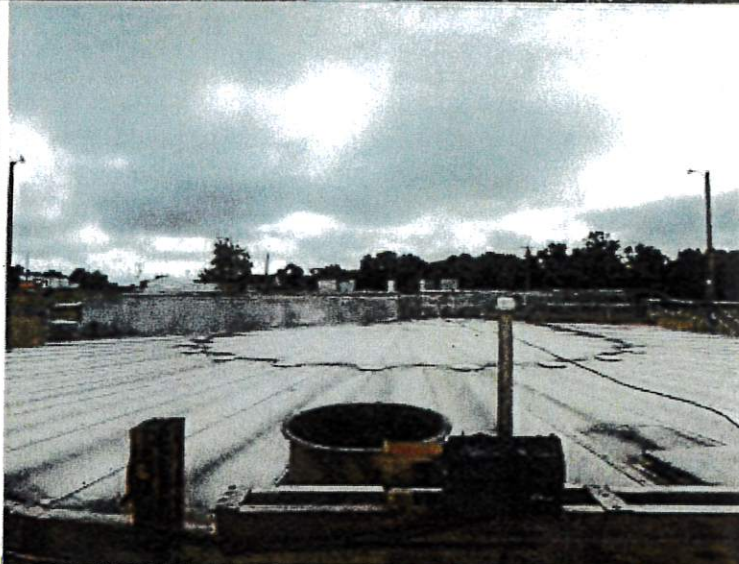
**Photo #:** 008  
**By:** John Chronister  
**Facility:** Dairy Farmers of America, Inc.  
**Permit:** MO-0002828  
**Location:** Texas County

The oxidation ditch is covered and is equipped with (6) rotors. Mr. Henley stated he tries to maintain at least (1) mg/L of dissolved oxygen (DO) in the ditch. At the time of the inspection, (3) rotors were running and DO in the ditch measured 3 mg/L. The number of rotors operating depends on the air temperature. More are required during hot weather and fewer during cold weather. The rotors are serviced periodically at the frequency recommended by the manufacturer.

**Description:** Oxidation ditch

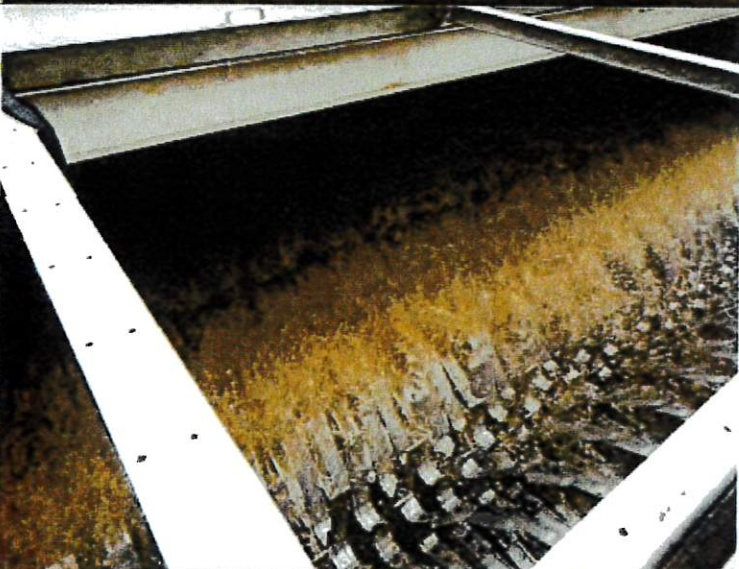
**Photo #:** 009  
**By:** John Chronister  
**Facility:** Dairy Farmers of America, Inc.  
**Permit:** MO-0002828  
**Location:** Texas County

**Description:** Rotor

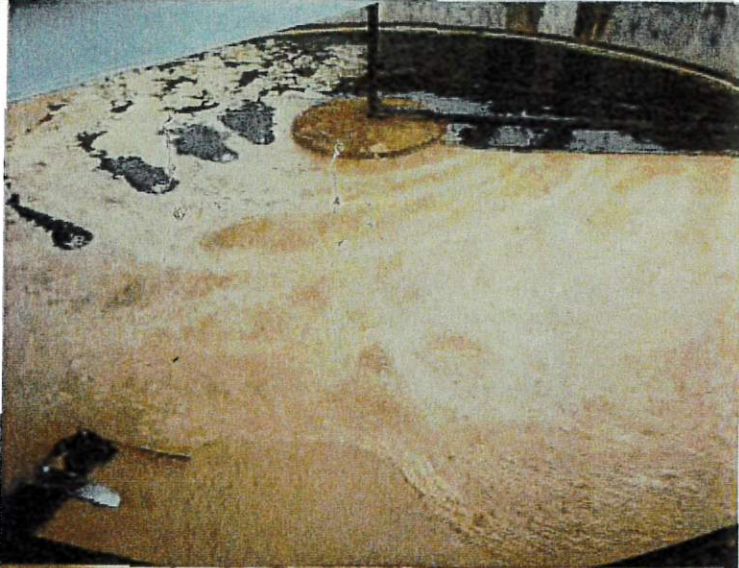
**Photo #:** 010  
**By:** John Chronister  
**Facility:** Dairy Farmers of America, Inc.  
**Permit:** MO-0002828  
**Location:** Texas County

Mixed liquor from the ditch flows through a splitter valve and into (2) final clarifiers. Like the pumps on the trickling filter, the splitter valve has been recently upgraded and replaced. There was a significant amount of foamy/frothy material floating on each clarifier. Sprinklers had been installed to settle the material, but it did not appear to be working well. Mr. Henley stated they were looking into a chemical treatment to eliminate this issue.

1. The material observed on the final clarifiers and in the "mixing basin" is similar in appearance to the material accumulating in and causing operational issues with the Cabool Wastewater Treatment Facility (WWTF).

**Description:** Final clarifier

**Required Action:** Every effort must be made to prevent the material observed on the final clarifiers and in the "mixing basin" from being discharged to the City of Cabool's collection system. It is possible this material is causing or contributing to interference and/or pass through at the Cabool WWTF, which is a violation of General Pretreatment Regulations, 40 CFR Part 403. Please keep the Department informed regarding efforts or planned upgrades to minimize these potential occurrences.

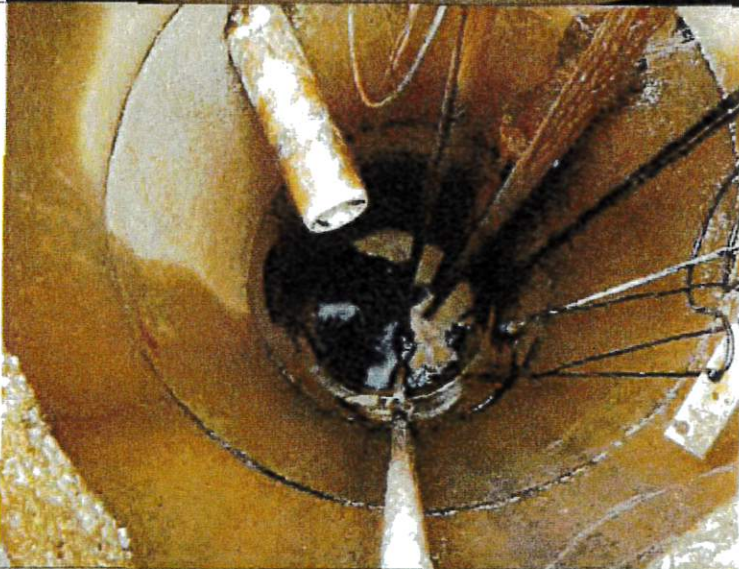
**Photo #:** 011  
**By:** John Chronister  
**Facility:** Dairy Farmers of America, Inc.  
**Permit:** MO-0002828  
**Location:** Texas County

The effluent from the final clarifiers discharges to an "effluent mixing basin" and then flows to the City of Cabool's collection system. I observed the same material in this basin that I observed in the final clarifiers.

**Description:** "Mixing basin"

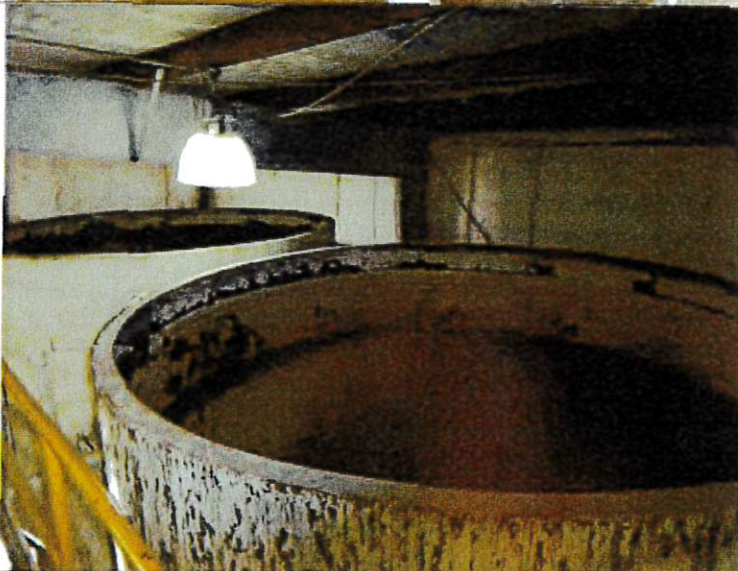
**Photo #:** 012  
**By:** John Chronister  
**Facility:** Dairy Farmers of America, Inc.  
**Permit:** MO-0002828  
**Location:** Texas County

**Description:** Decant tanks

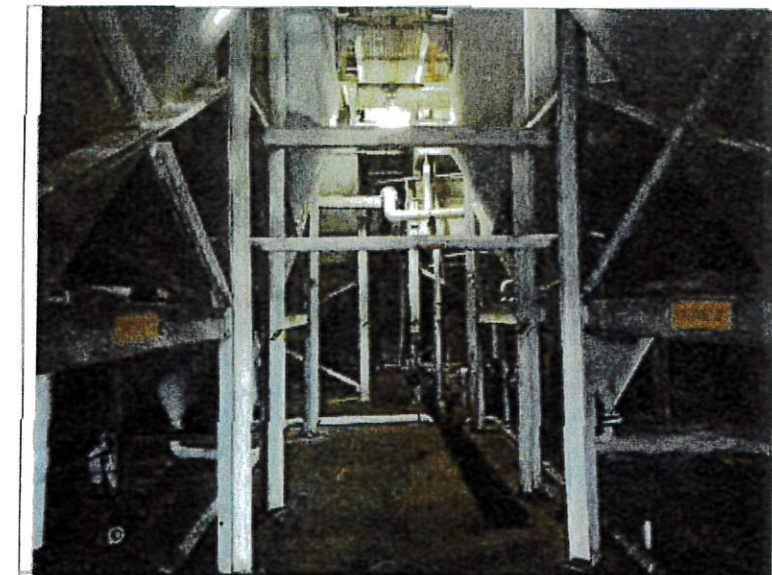
**Photo #: 013**  
**By:** John Chronister  
**Facility:** Dairy Farmers of America, Inc.  
**Permit:** MO-0002828  
**Location:** Texas County

**Description:** Decant tanks

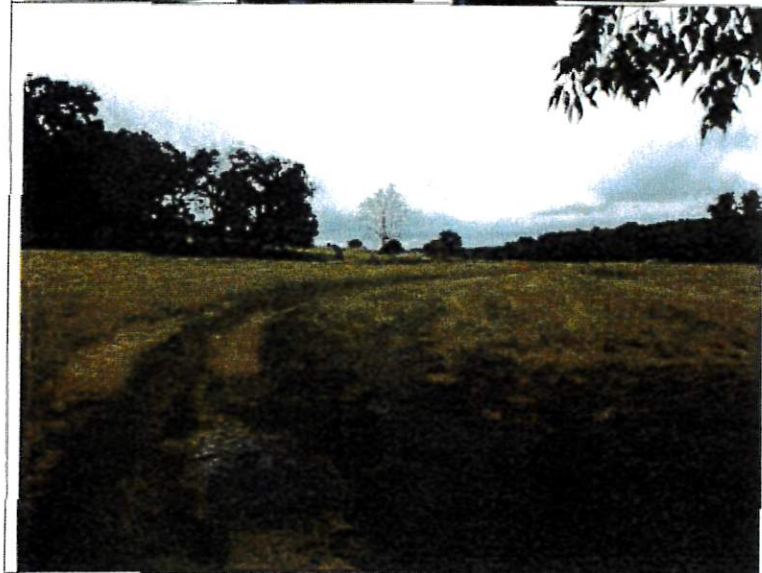
**Photo #: 015**  
**By:** John Chronister  
**Facility:** Dairy Farmers of America, Inc.  
**Permit:** MO-0002828  
**Location:** Texas County

We thanked Mr. Riley and Mr. Collins for their time and assistance and then followed Mr. Henley to one of the land application fields. The site was fenced, the gate was locked, and it appeared to be well maintained. However, it was not marked as required by MSOP MO-0002828. According to Mr. Henley, not all of the sites listed on the permit are used and none of the sites used are marked. I recommended that sites without contracts should be removed from their permit and those still used must be marked.

3. The permitted features were not marked as required by MSOP MO-0002828.

**Description:** Land application field

**Required action:** By September 2, 2019, post signs at permitted features with their respective numbers (Permitted Feature 005, Permitted Feature 006, etc).
